## GLOSSOPDALE & LONGDENDALE ARCHAEOLOGICAL SOCIETY

### Report for the Derbyshire Historic Environment Record on a hillfort of presumed Iron Age date at Mouselow, Dinting, Glossop SK 028 955

#### Summary

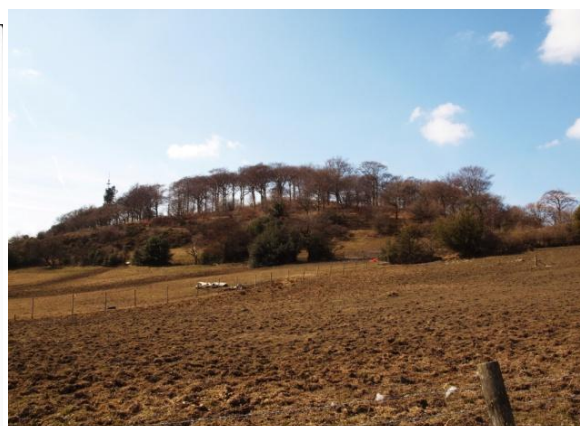
Fig 8 View looking NW from North Road

Since that time regular grazing of the summit enclosure has ceased, and the uncontrolled growth of ground cover combined with the already-heavy tree cover has made it very difficult to see and follow surface features within the enclosure even in winter. When viewed in winter from the south-east (North Road) (Fig 8) a horizontal linear feature is clearly visible running below the line of the presumed Norman ditch, and Glynis Reeve's 1993 booklet, "Castle Hill - Glossop's Other Fort", contains what appears to be a photograph of it captioned *"Shallow outer rampart on north-western face"*, but it is now, due to growth of vegetation, difficult even to locate on a walkover and even more difficult to follow round the hill.

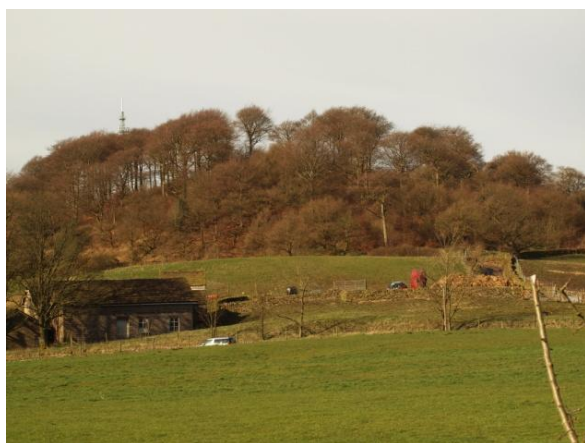
Fig 9 View of outer rampart from NE (along line A-B on plan)

In addition, it would have been necessary, on the north-east side, to defend the spur of land adjacent to Bettenhill Farm. It is most likely, therefore, that the fort was basically ovoid in plan with a flattened base, broadest to the south-west, and with the strongest fortifications there and on the north-east. However, the earthworks on the south-west appear to have been very substantially degraded, presumably by human action, since Watson saw them, and any ramparts on the steep north and south-east sides will additionally have been vulnerable to erosion; there appears in particular to have been a very substantial loss of ground from the south-east side. The double ditch and rampart on the north-east side appears therefore to be the best-preserved part of the fort, the outer rampart still standing 3-4 metres above the surrounding land.

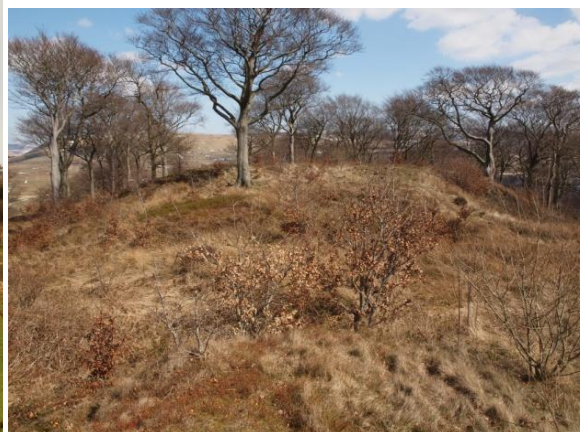
Fig 10 Norman motte looking east

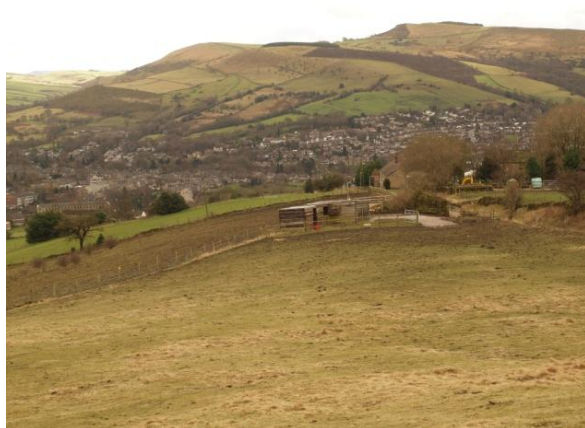
Fig 11 View along ridge to south (Hilltop on right)

3. To the south, immediately east of Hilltop hamlet, are what appear to be two parallel embankments, about 30 metres apart and 275 metres in length, running east of Hilltop Road just below the ridge which runs due south from Mouselow, and pointing towards the summit. Viewed from the north from ground level (Fig 11) they can just be made out, the height differences from this viewpoint being less than 1 metre, but they appear much more prominently in a view from lower ground to the south-east (Fig 12). They appear on the Lidar to lead, beyond the point where they would intersect with the ramparts, onto a single embankment or causeway which then curves to the north-east and climbs up to the summit.

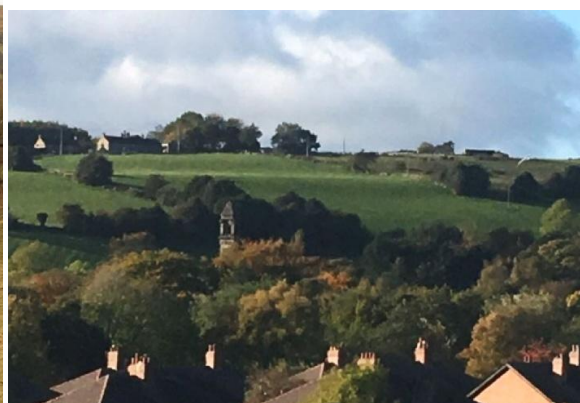
Fig 12 View of Hilltop looking NW from SK 034 945 (Mike Brown)
